The Hubble Space Telescope Optical Systems Failure Report

November 1990

NASA

(NASA-TM-103443) THE HUBBLE SPACE TELESCOPE
OPTICAL SYSTEMS FAILURE REPORT (NASA)
107 p CSCL 03A

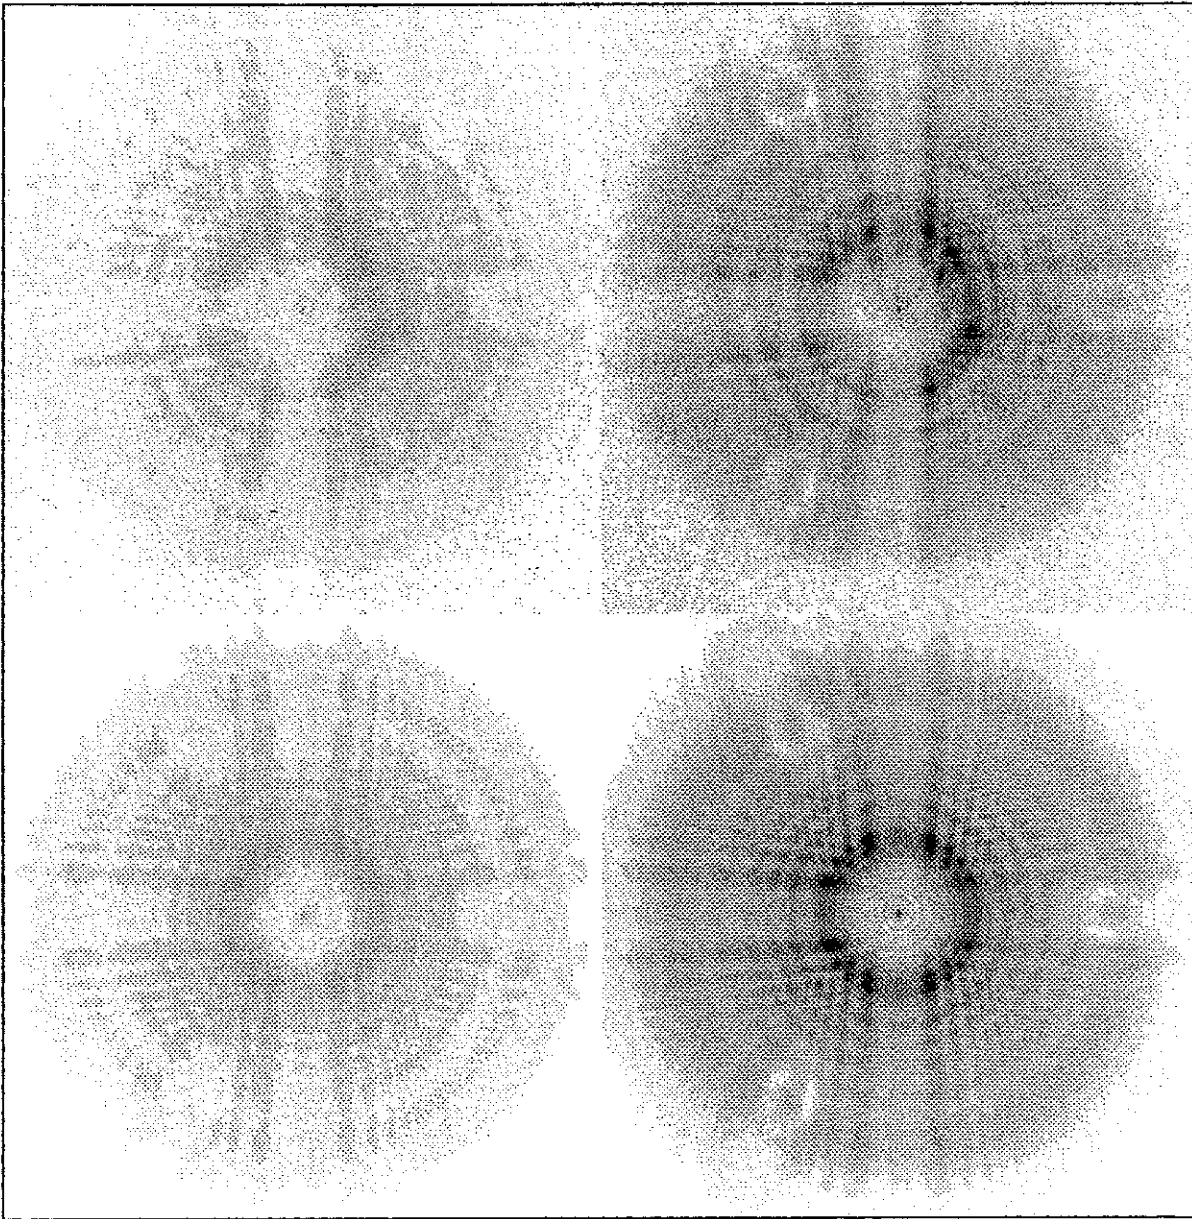
(b) Recorded image of the PC5 star taken on June 21, 1990, with a $-300\text{-}\mu\text{m}$ inside focus.

Figure 6-1 (continued). The images in both (a) and (b) show a linear-intensity display on the left, and a logarithmic ("stretched") image display on the right. The focal position denotes the position of the secondary mirror. (Data were supplied by Dr. Jon Holtzman.)

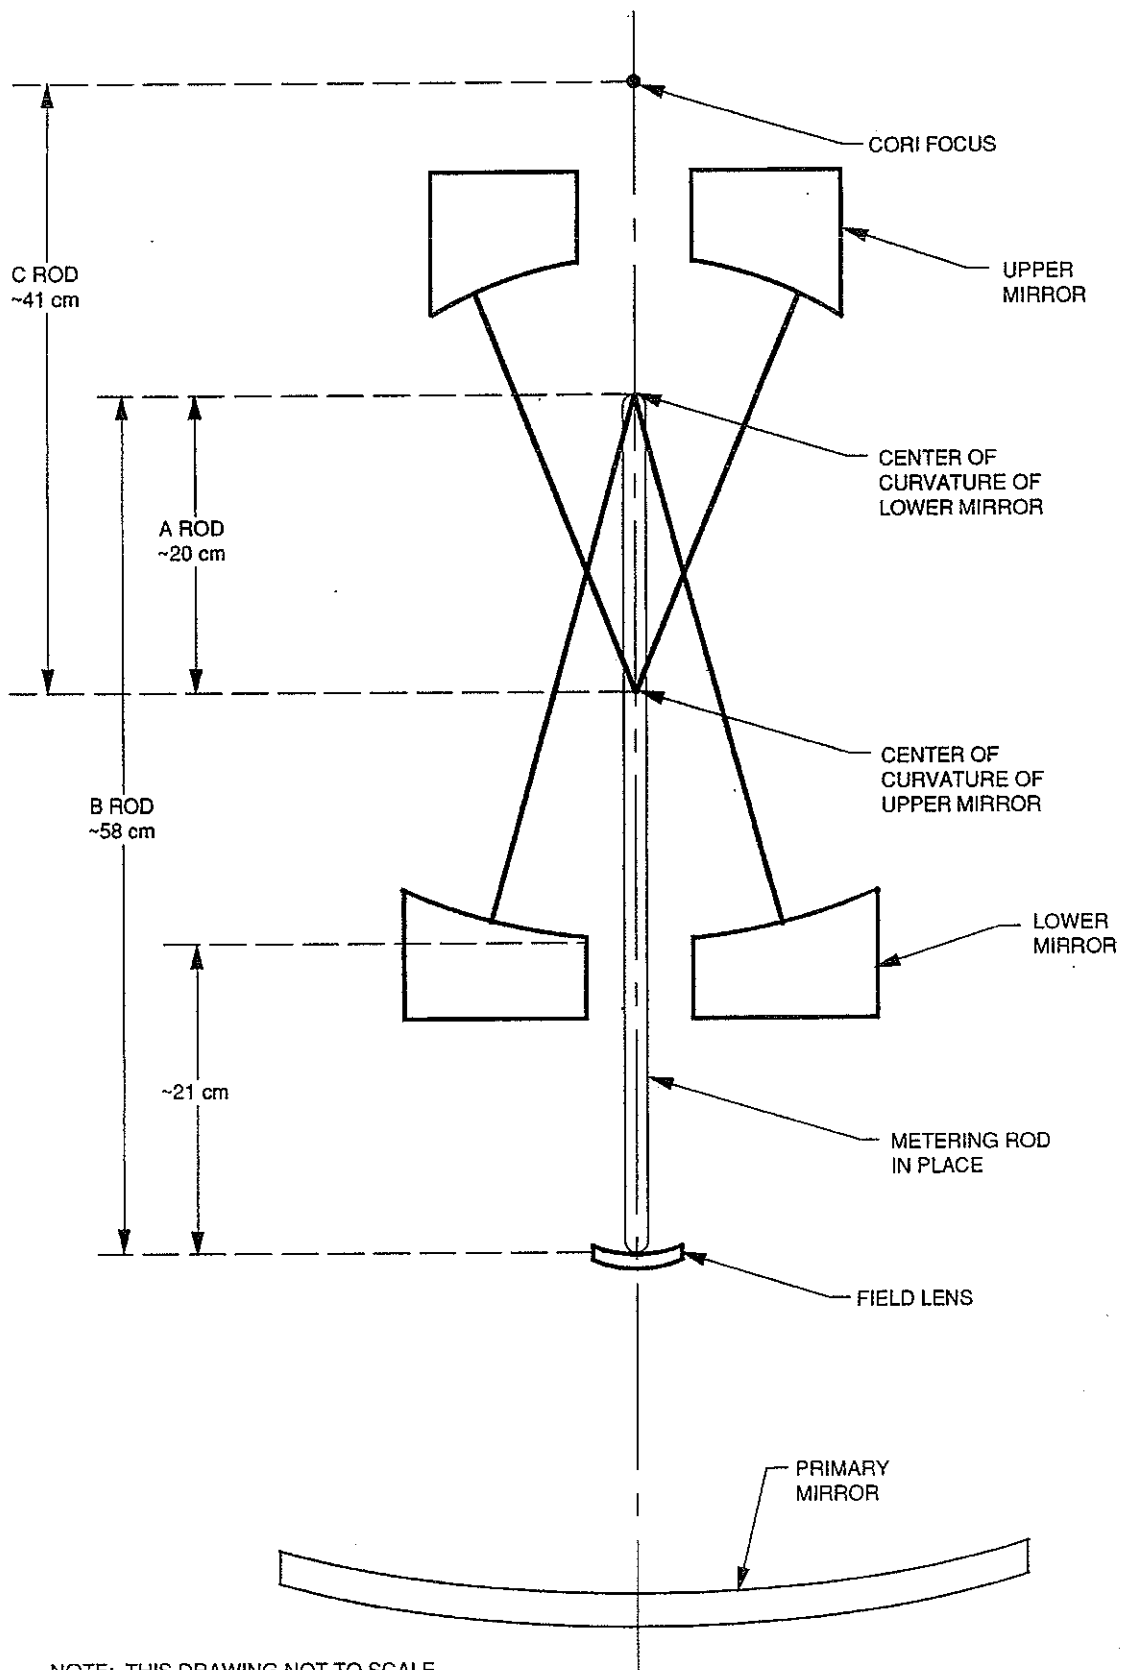
Figure 7-1. Position of metering rods used to space optical elements in the reflective null corrector.

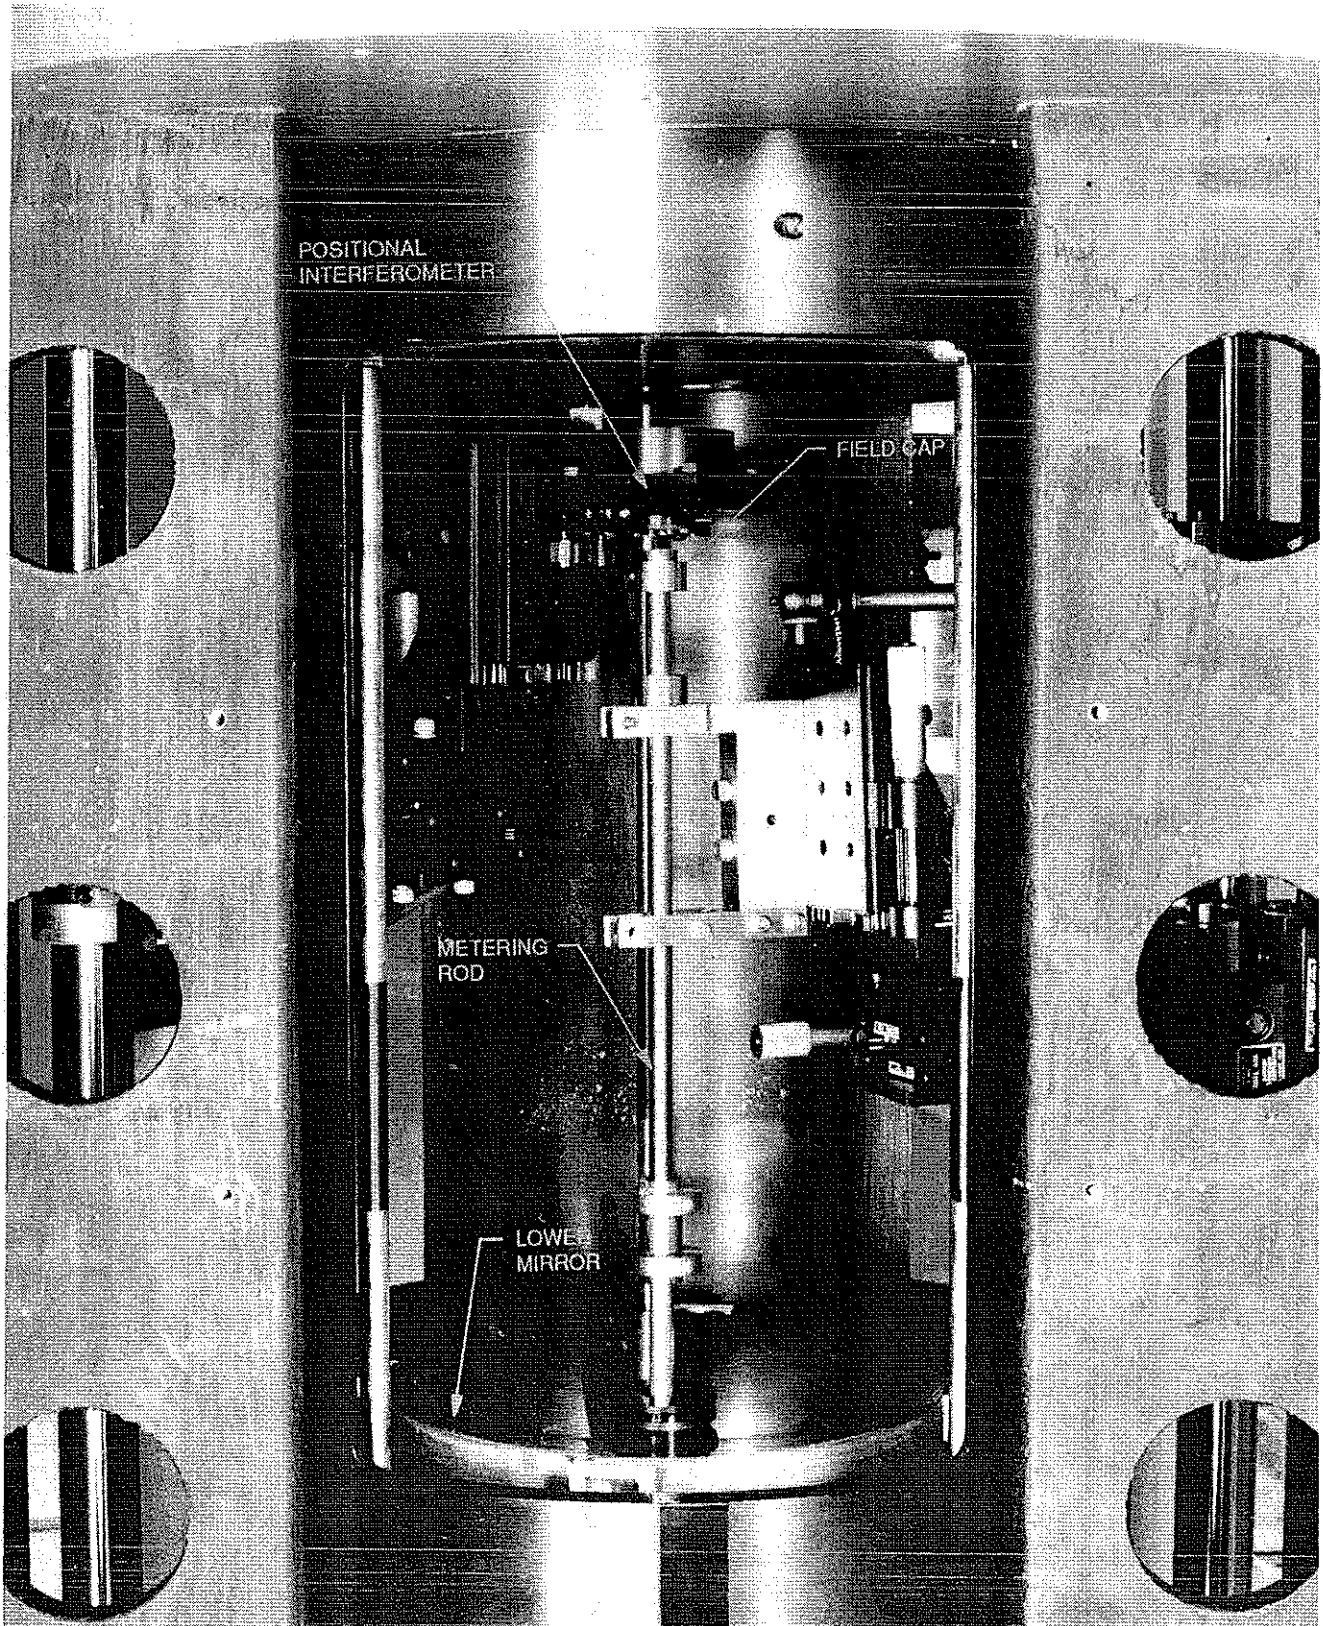
Figure 7-3. Metering rod in position between the field lens and the center of curvature of the lower mirror in the reflective null corrector.

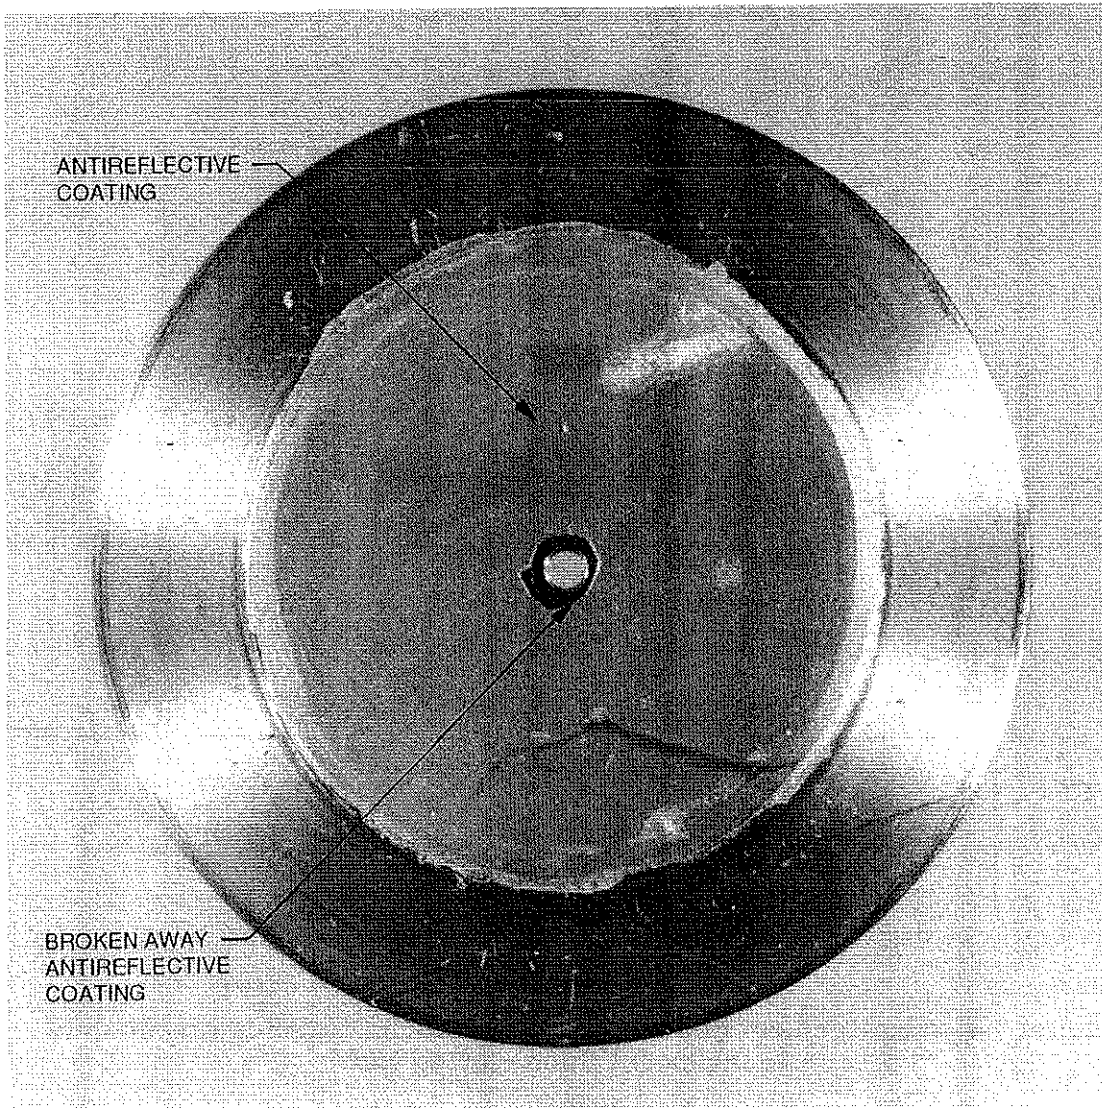
BROKEN AWAY
ANTIREFLECTIVE
COATING

Figure 7-5. Top view of the field cap, showing the aperture and the area where the antireflective coating had broken away.

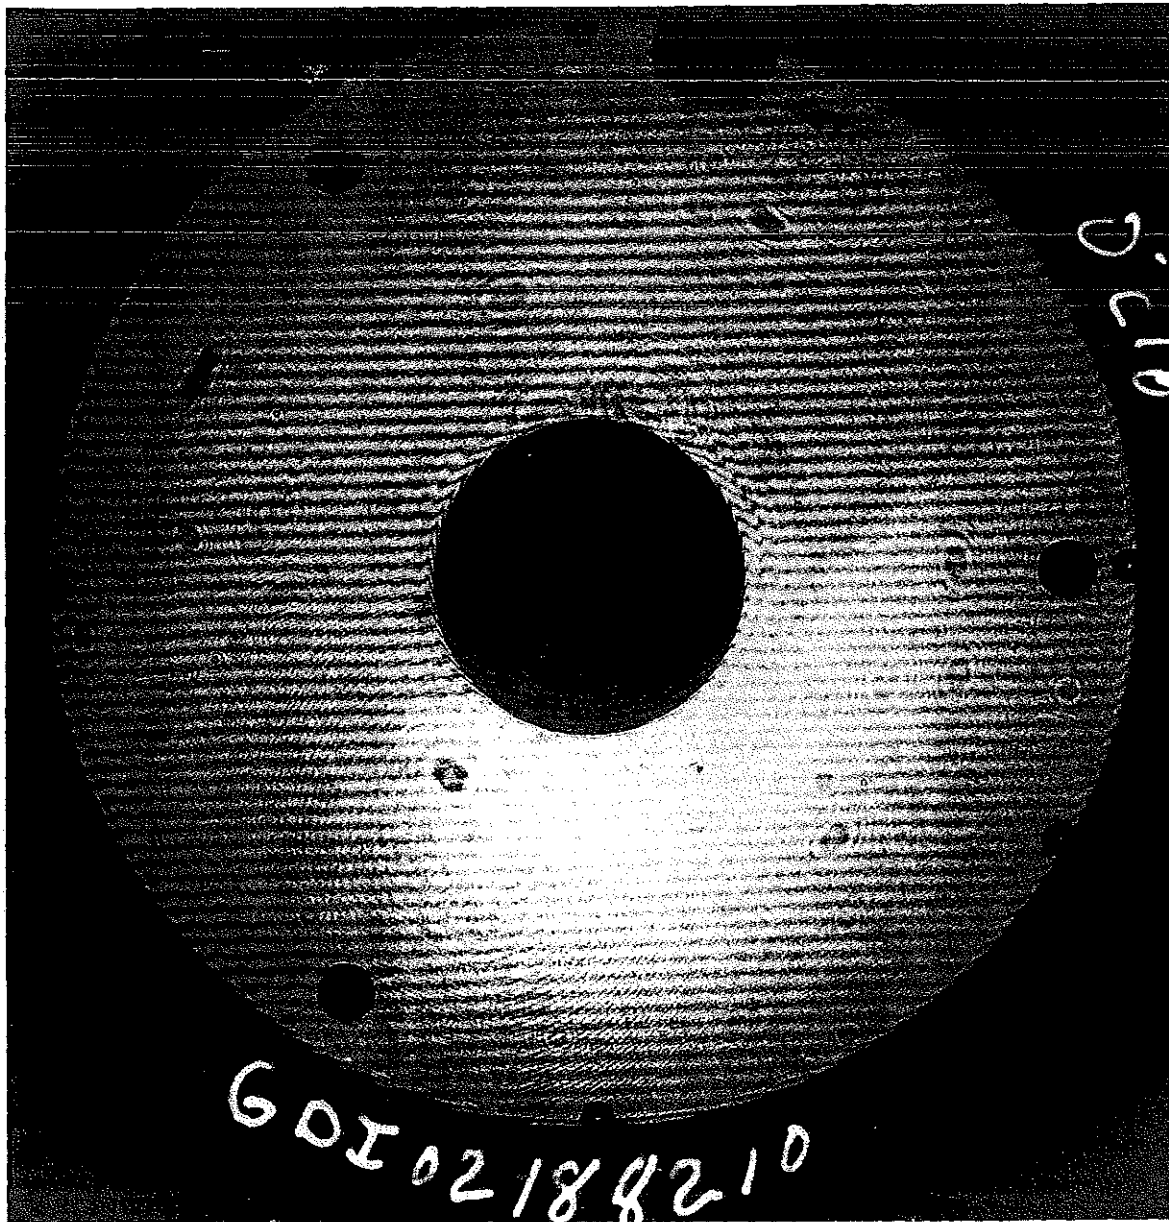
Figure D-1. RNC interferogram of the primary mirror, taken in February 1982.

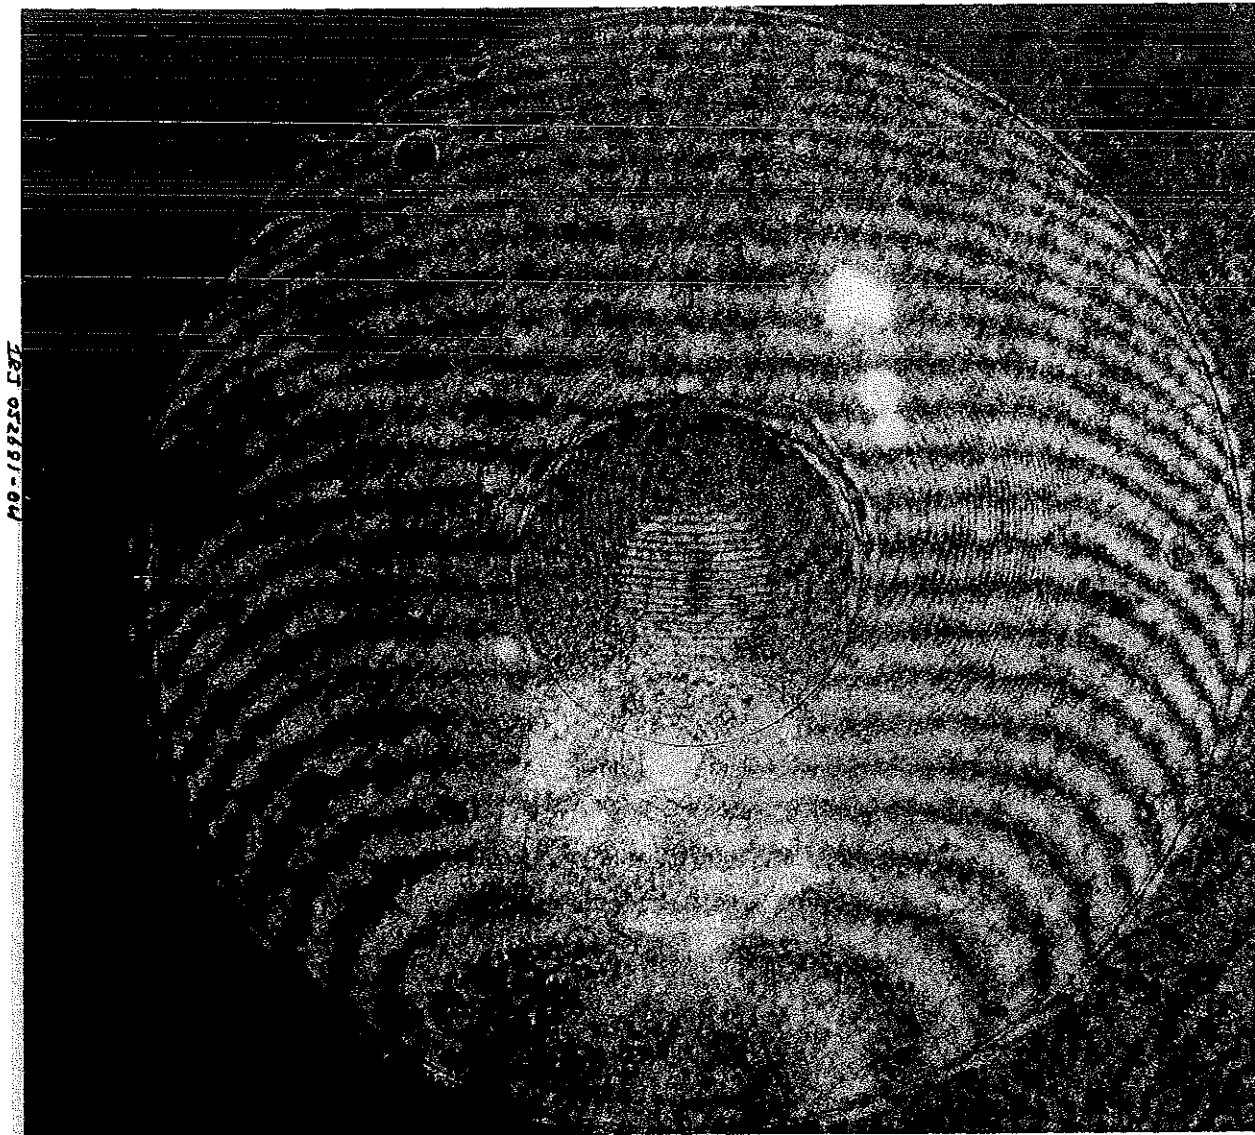
Figure D-2. RvNC interferogram of the primary mirror, taken in May 1981.

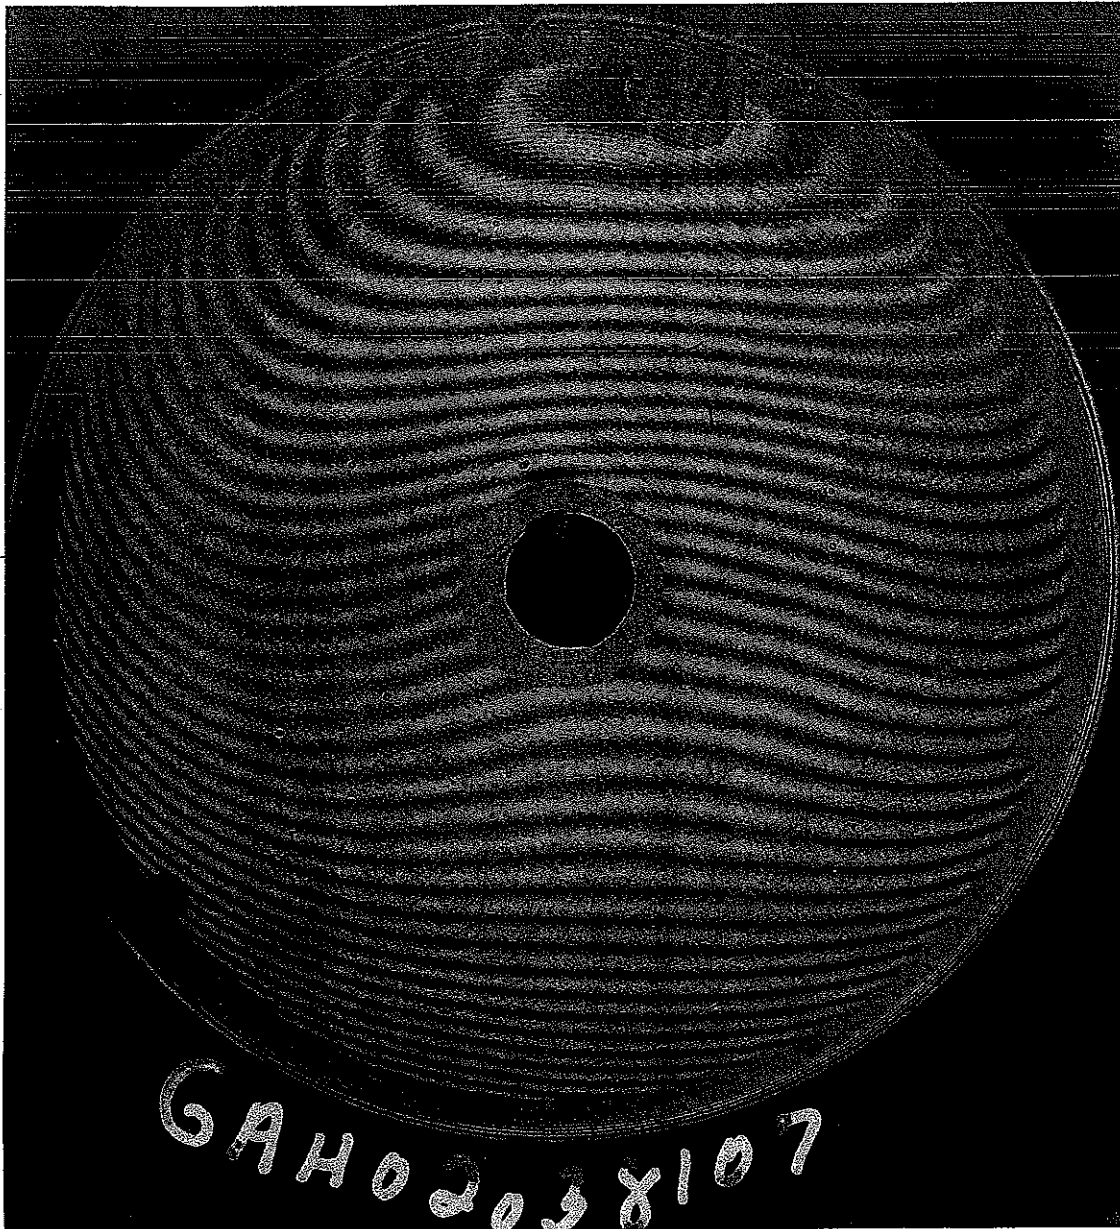
Figure D-3. INC interferogram of the reflective null corrector, taken in February 1981.
